Analysis of Factors Causing Erosion and Flooding in Manleuana Village, Dom Aleixo District, Dili Regency

Devia Amelia Maria Antonia da Costa¹, Jonio dos Santos,² Rini Retnowati³

Universidade da Paz, Timor-Leste^{1,2,3}

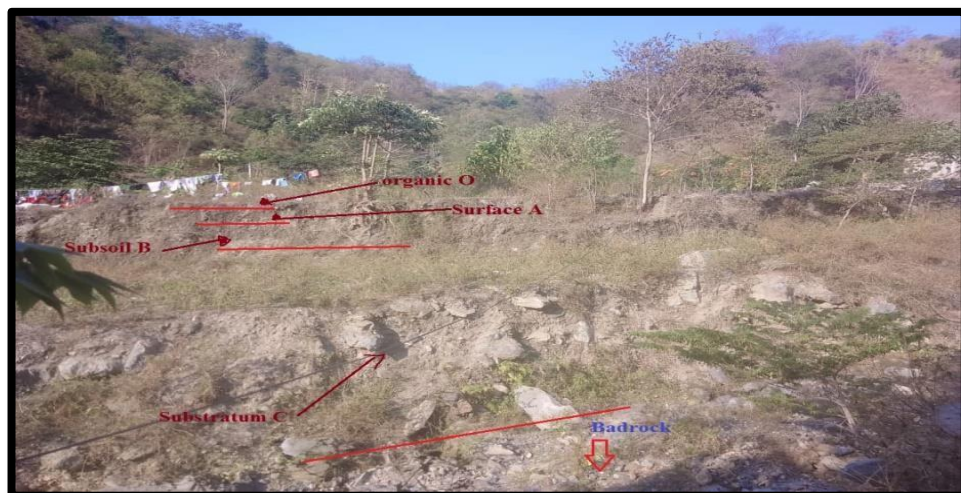
Figure 2: Soil Horizon
Figure 2: Soil Horizon in Manleuana Village, Dom-Aleixu District, Dili Regency.
Source: Researcher (elevation 174.64 masl)

The soil characteristics factor received a score of 79.02 present. And based on direct observations in the field, the land area in the research area is prone to erosion due to the lack of organic material, high weathering levels, lack of vegetation that binds aggregates or soil. Other influential observation results are the slope gradient, and its lithology such as clay, because of this, when heavy and long rain with high rainfall intensity can cause erosion due to the load given by rainwater to the soil, while the infiltration capacity of the soil is lacking and results in the load and the emergence of erosion whose path follows the existing slope gradient.

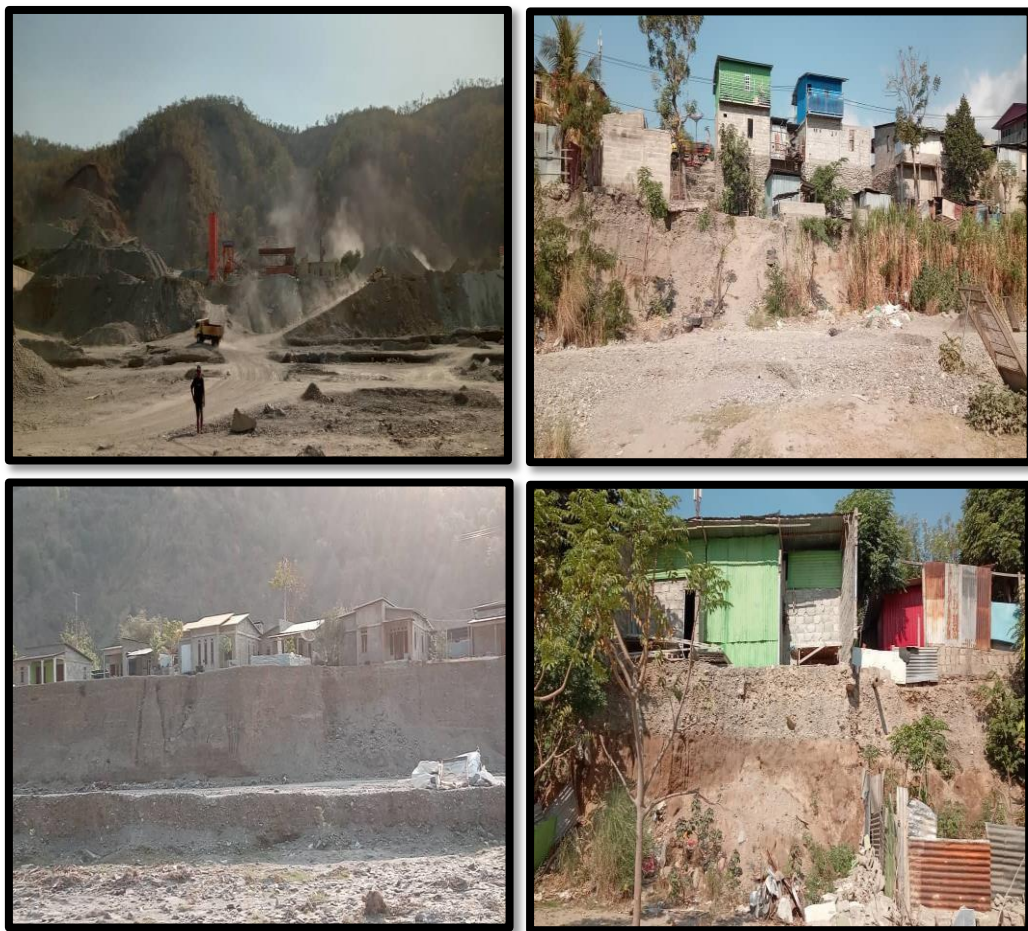
Figure 3: Human behaviour in land use in Manleuana Village, Dom-Aleixu District, Dili Regency. Source: Researcher 2023

The human behaviour factor received a score of 77.07 present, based on the observation results, it was also found that human behaviour is one of the factors that can accelerate the erosion process because bad human behaviour is a negative factor in land degradation, but humans also play an important role in preventing erosion.

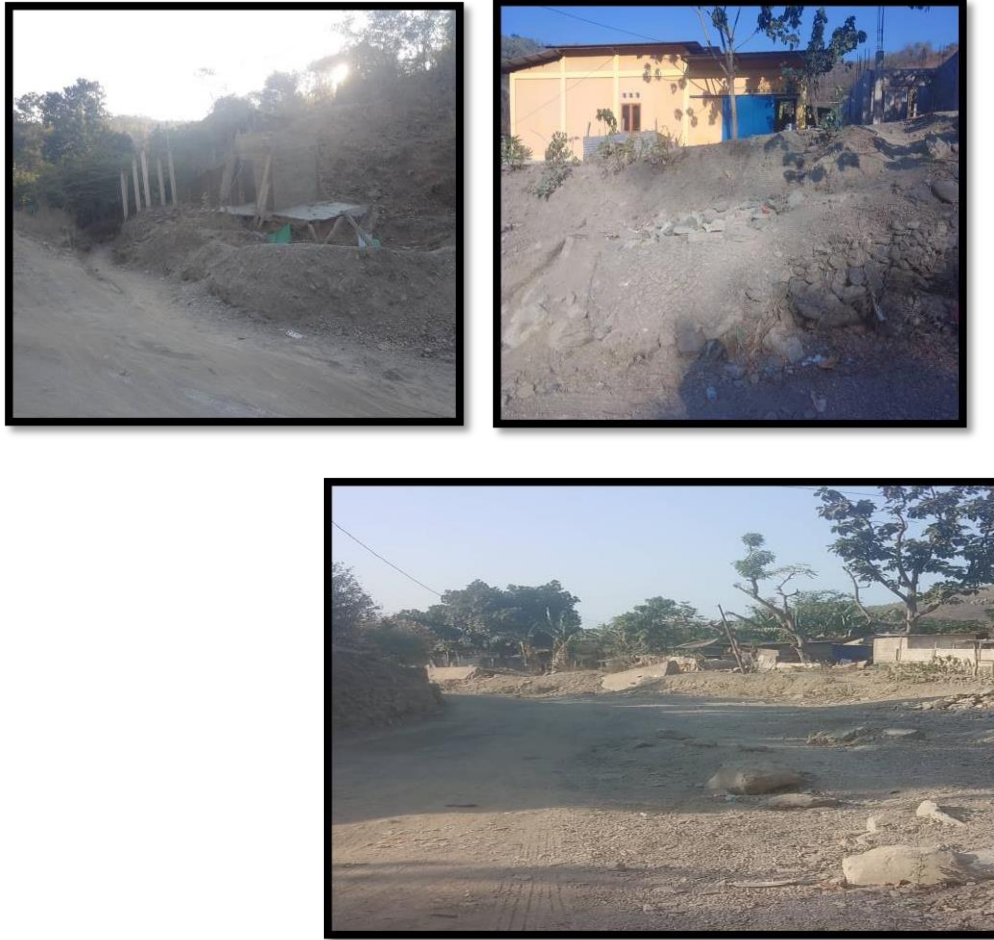
Figure 3: Condition of the River Coordinate -8.584862S/120.543759E, 109.27 meters above sea level Source: Researcher 2023

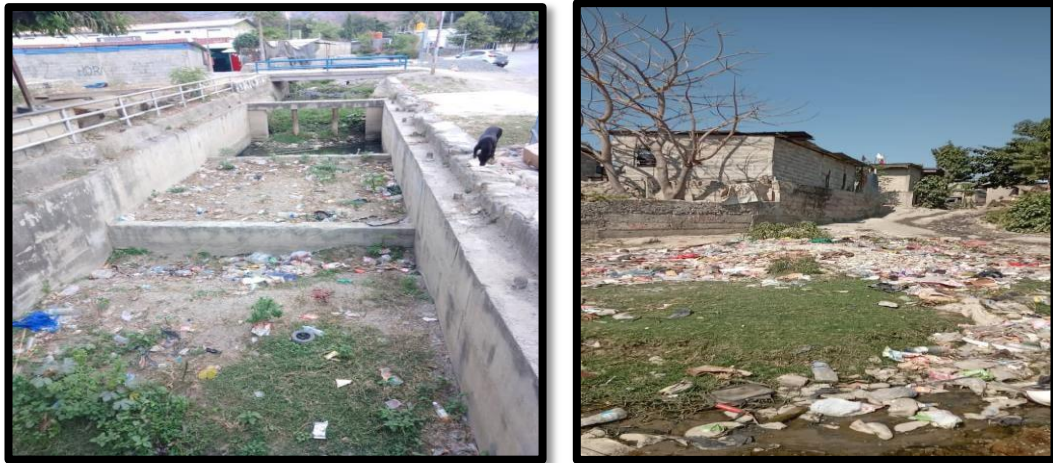
Gambar No.4 Bagian kiri sedimentasi di drainase, bagian kanan pembuangan sampah sembarangan di dalam sungai oleh masyarakat yang tinggal di datarang banjir
Sumber : Peneliti 2023

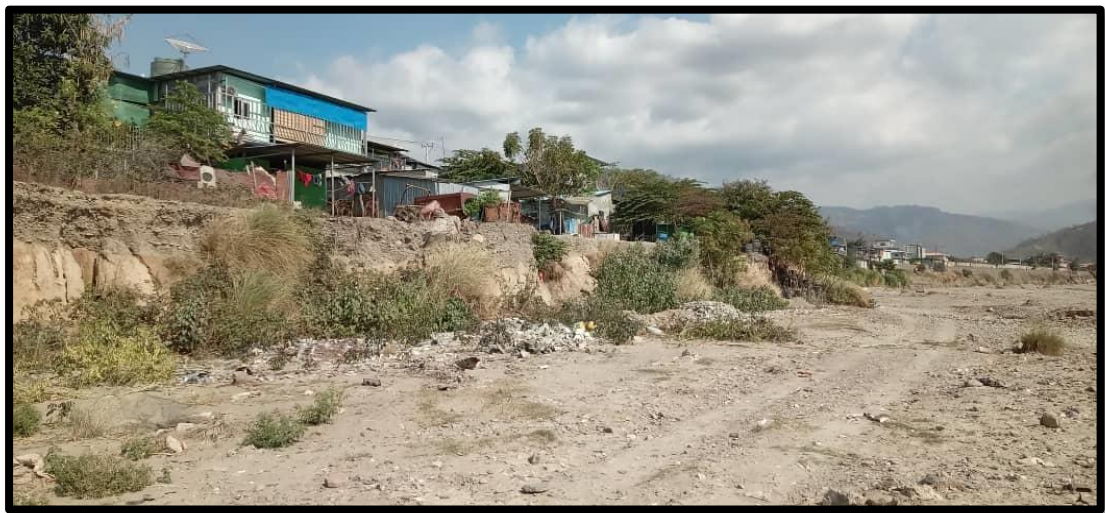
Figure No. 5: Communities living in floodplains but already within the river basin.
Source: Researcher 2023

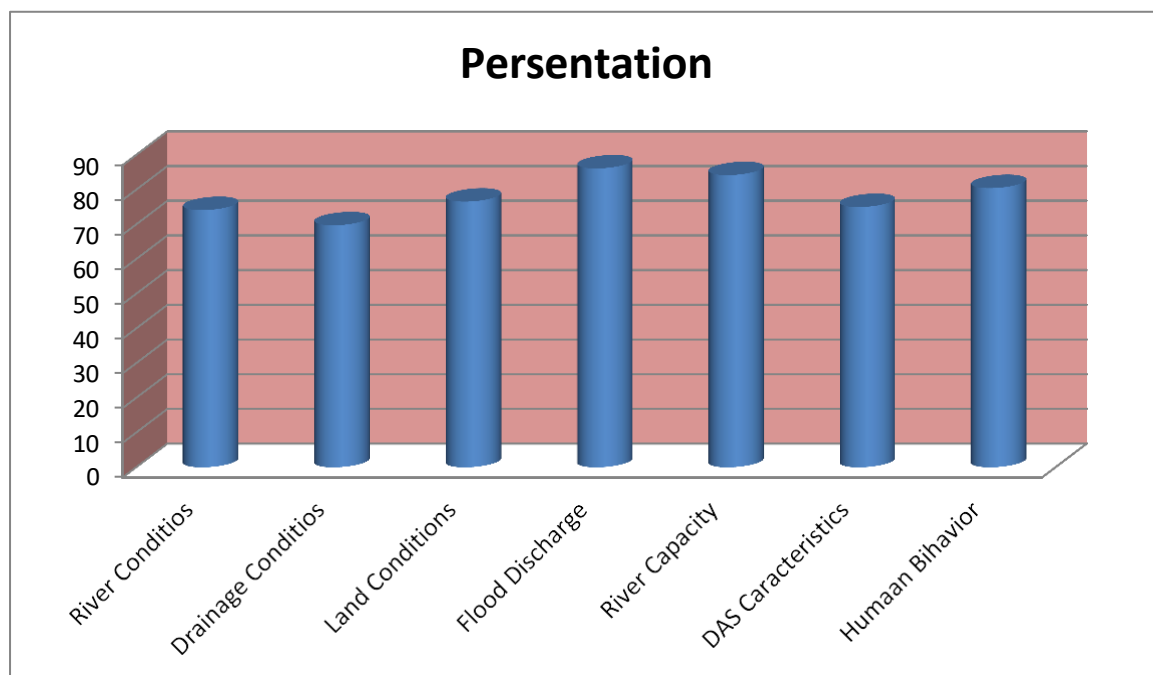
Picture No.25 Graphic Diagram Interpretation of flood score based on interval

No.	Factor Indicators	Presents %	Category
1	River Conditions	74.15	Agree
2	Drainage Conditions	69.76	Agree

3	Soil Conditions	76.59	Agree
4	Flood Discharge	86.16	Strongly Agree
5	River Capacity	84.23	Strongly Agree
6	Watershed Characteristics	75.03	Agree
7	Human Behaviour	80.49	Strongly Agree

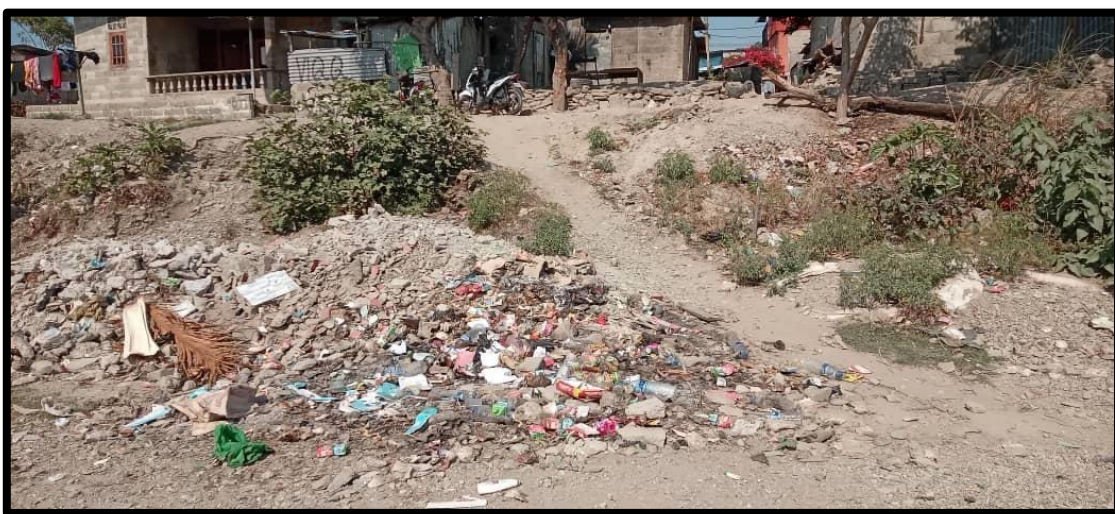
picture No.19.the population's house is in the river and the garbage is thrown into the river.

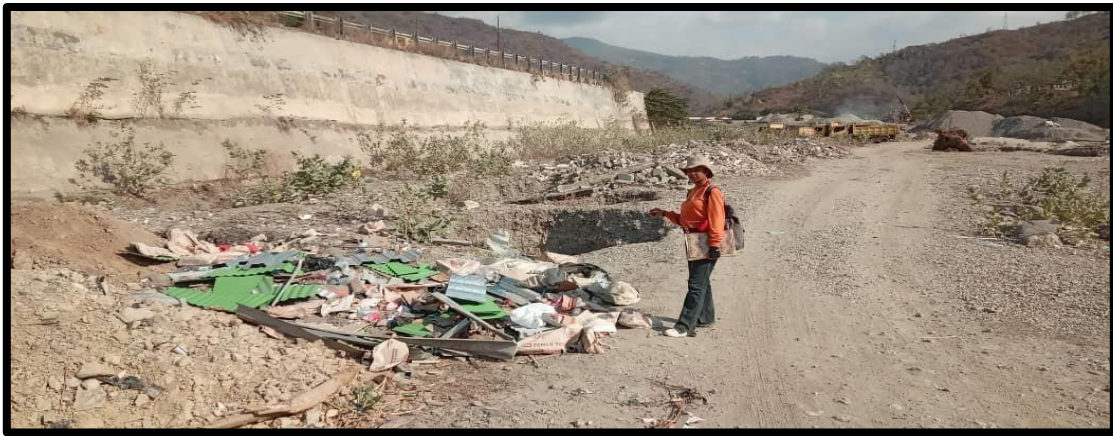
Picture Now.20. Different types of garbage in the river Sources : Researcher 2023
